UNITED STATES ENVIRONMENTAL PROTECTION AGENCY REGION 8

Subject: POLREP #1 (Initial Pollution Report) – Removal Assessment
Gold King Mine Site
Site #085M
Silverton, CO
Latitude: 37.8945 Longitude: -107.6384

Date: September 25, 2014

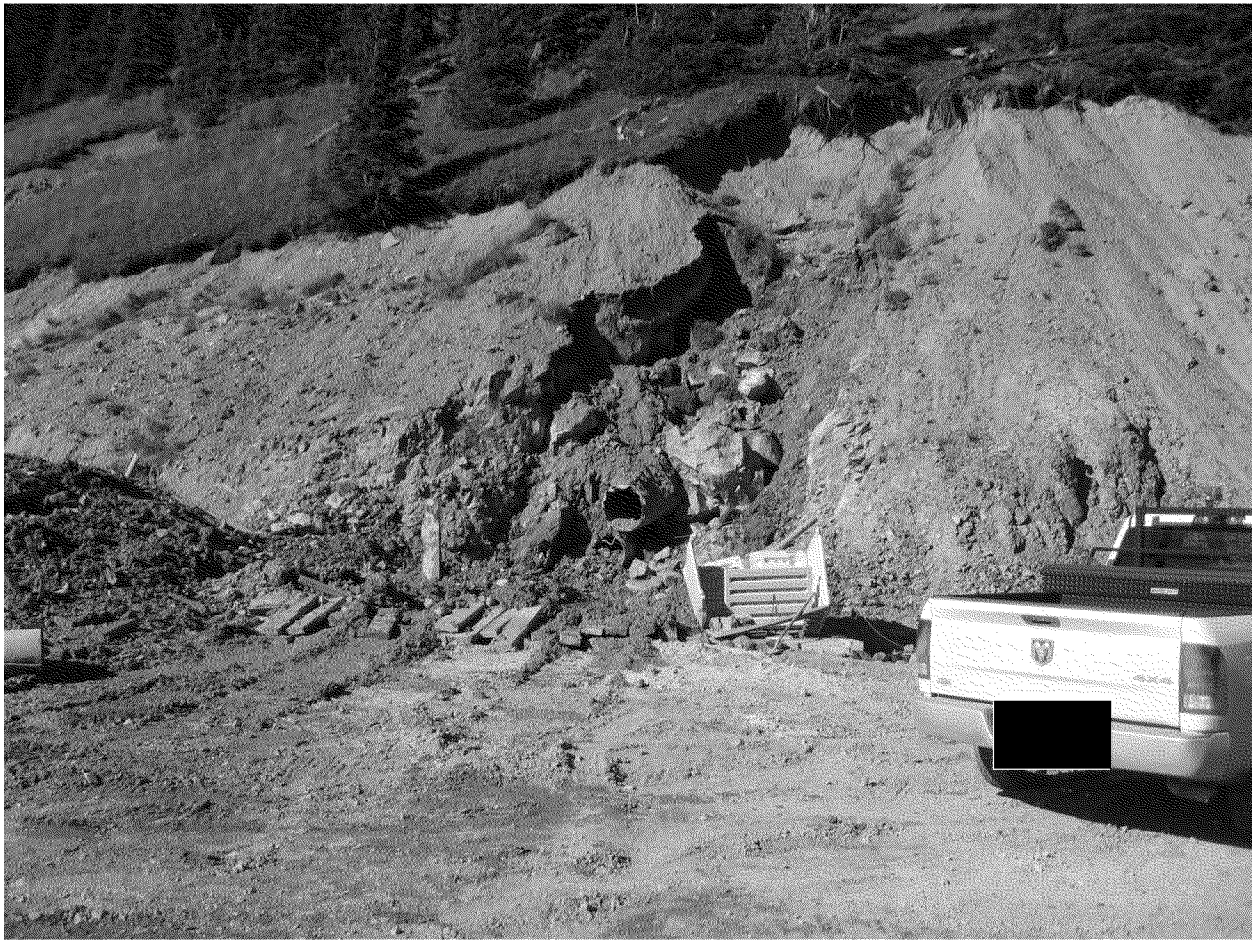
- The condition that was exposed revealed that two 24 inch pipe were in the tunnel blockage adjacent to the top (roof) of the adit. Timbers were observed on the sides and a cap timber was also observed by the contractor. The presence of the 2 – 24 inch pipe indicated the current flow of water was coming out only four feet below the roof, and then there was approximately 6 feet of impounded water below the level of the dump surface. (See Photo below)

Gold King Mine – 9/11/14: collapsed adit pipe near roof of the adit/tunnel.

- The following day, the drain pipe (2 - 12 inch) were placed at the base of the blockage to capture the on-going mine drainage and direct flow into the existing concrete flume channel previously installed at the Gold King 7th Level Mine collapsed portal. In order to do route the water into the channel, a section was removed from the concrete channel north wall (approximately 26" by 10") to allow for construction. The two 12" diameter PVC (polyvinyl chloride) pipes were installed to better direct adit drainage water from the portal into the concrete channel. Geo-fabric, crushed rock, and quick-dry concrete was used to secure the pipes in place. The portal area was backfilled and compacted with additional loads of crushed rock to maintain a stable surface at the portal for potential future work.

In 2015, additional work to reopen the portal will be performed. The water management system to be operated during the mine entry will be evaluated during the winter. Installation of the temporary system will occur prior to entry anticipated for July 2015. Based on previous activities, it is estimated that the work may require four weeks to be completed, including the set up time for the water management system.
